ALERT

Number: SV4-RS-AB01
Original issue: 07 JUL 2021

SUBJECT: main landing gear, part 405B control/modification

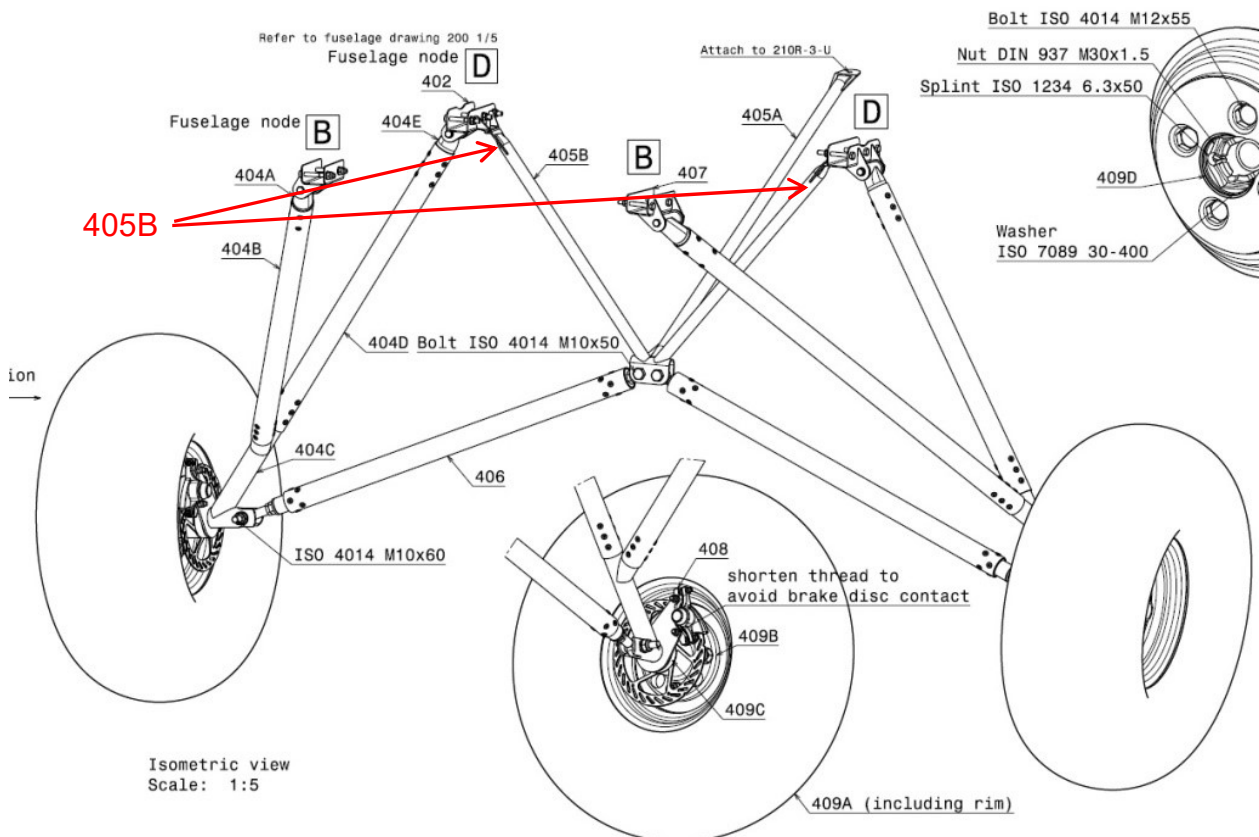
On a SV4-RS totalising something more than 400 hours, the triangular strut (part number 405B, see picture below) of the main landing gear broke on one side of the attachment points after landing. The construction however permitted to taxi back to the hangar without difficulties. There were no injuries and no other damages on the aircraft.

As a result of thorough investigation, it appeared that the parts broke due to a fatigue failure on one gusset of part number 405B of the main landing gear.

Part 405B will have to be changed on every SV4-RS, once the parts will become available. Right now, we started production of a sufficient number of parts to supply every customer. The customers that have their aircraft flying will be served first. Disassembly and assembly instructions will be provided with the parts.

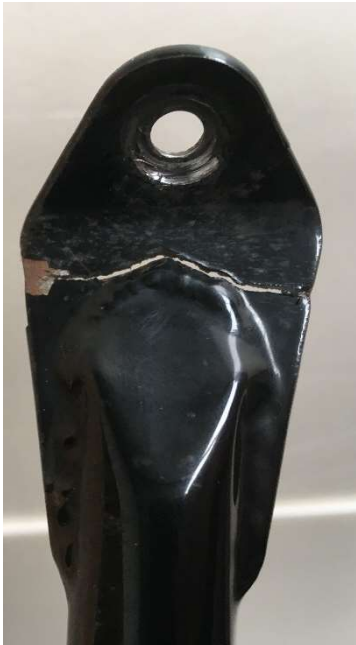
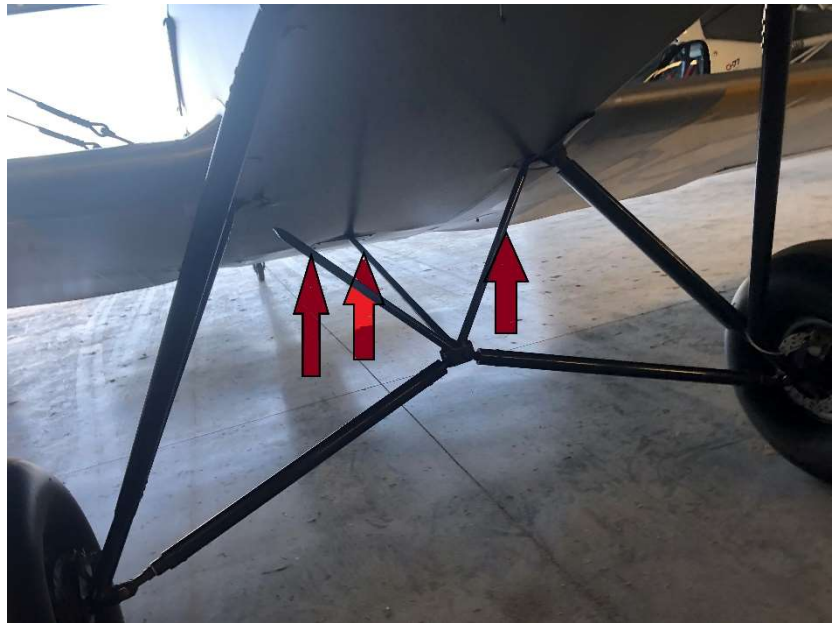
Up to then, we ask you to survey the main landing gear in-depth before and after every flight. If part 405B of your aircraft shows a fissure or a crack on the gusset shown on the picture hereafter, we will provide the old version that has equipped every SV4-RS until now, to permit you to continue flying until the new parts are ready to be delivered.

Part 405B must be changed at the latest when the first crack appears in the paint of the gusset (see picture below).
